Please find attached a building survey and structural appraisal for the requested property in Torquay.

STRUCTURAL APPRIASAL

Property: Villa (Detached Property)
Torquay
Devon
Client: Mr A N Other
Inspected on: 10th Nov ****
Report Ref: ABCD
Inspected by: Senior Surveyor

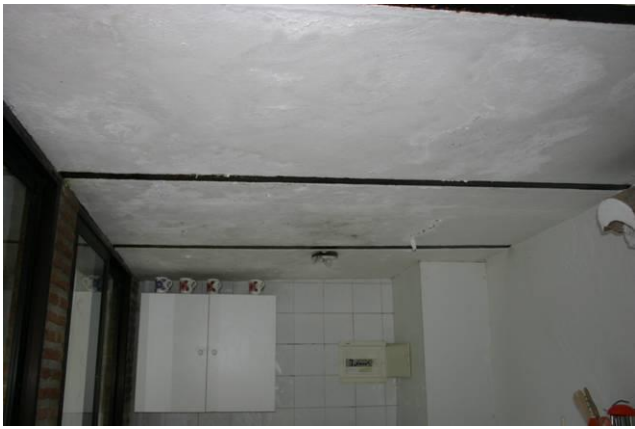
A

DAMP: Considering the age of the building the main area of the property appeared to be devoid of damp. The building had been unoccupied and there was no evidence of damp on this floor. However at Ground Floor/Basement Floor level there is damp evident in the small Kitchenette. **(A)** This is extensive throughout the ceiling slab and has caused mould and algae to form above the window on the main property wall. **(C)** In the room directly behind this Kitchen area there is also extensive damp above the window and on the ceiling slab. **(B)** I believe that this area is an addition to the property where a slab has been cast and the area below converted into rooms, it would appear that the integrity of the Damp Proof Membrane has been compromised. As stated before movement on this slab area can be clearly seen and further investigation would be essential.

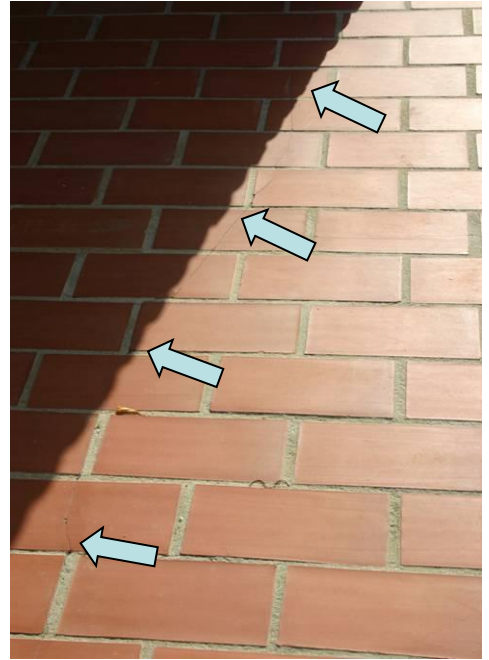
D

Structural fracturing is affecting the slab directly above the entrance to the basement apartment. It can be clearly seen as a crack in the structural slab. Above, this apparent failure can be seen as a dip in the tiled area, again this can be seen as two failure cracks in the tiles. **(D,E)** It is our opinion that movement damage is occurring and ongoing as the crack has been repaired and continued movement has occurred.

CEILINGS: The ceilings in the main dwelling are of concrete construction and the only sign of movement appears to be in the entrance way into the basement apartment where there appears to be a movement crack. Please see previous notes under Structural Slabs. In all other areas the ceiling appears to be in good order.

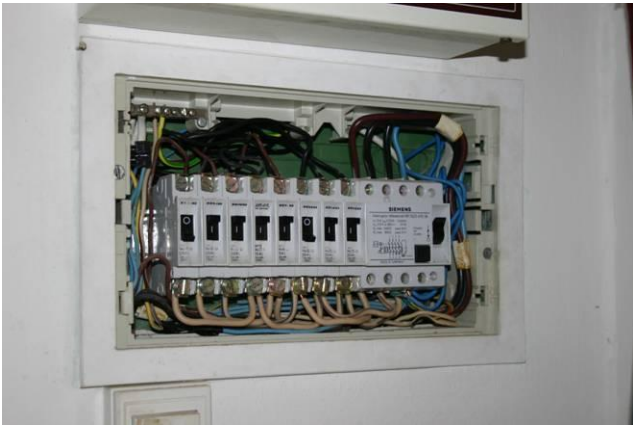
F

ELECTRICS: The building has at some point been rewired as a Consumer unit with both RCD and MCBs is now the main distribution board. The colour of the wire coating would imply though that this was some time ago and in my opinion the cabling is coming to the end of its serviceable life. **(F)**. At some point an electric shower has been installed and the cabling has been left hanging across the ceiling. This would be against all regulations in any room, but in a bathroom this must be addressed before the shower is used. The cable is of a flex variety and not at all suitable for this type of installation. It is imperative that this shower is wired correctly before any use. **(G)** The electrics were not tested and it would be advisable to have an electrical integrity and continuity test carried out, paying particular attention to the bonding and earthing.

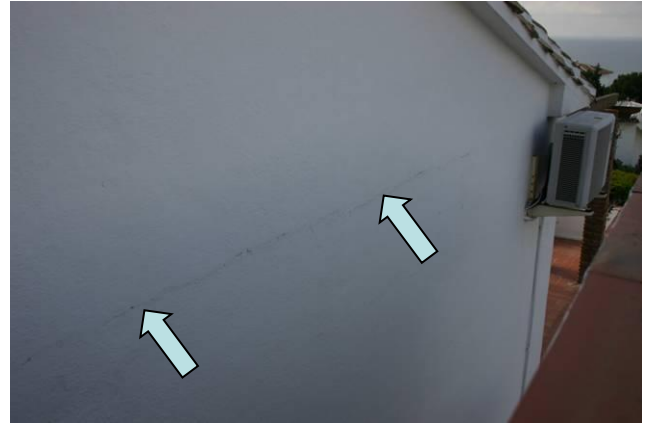
J

The external walls can be described as typical Spanish style with rough rendering. Although some minor patch repairs to the render have been executed, it is our opinion that the vast majority still has a usable life. It must be noted though that the building has been recently repainted externally and although this was probably done for aesthetic purposes it does unfortunately hide any repaired movement cracks. The only exception is a fairly large crack in the render on the West elevation, this crack is irregular and I believe is simply a failure in the rendering, its is not concurrent with a structural failure which you would expect to run as a straight line along the ring beam, as it is a fairly large crack though I would recommend that a small area of render is removed from around this failure to ensure that something more serious is not occurring. **(J)** However the general overview of the external rendering appeared to be good.

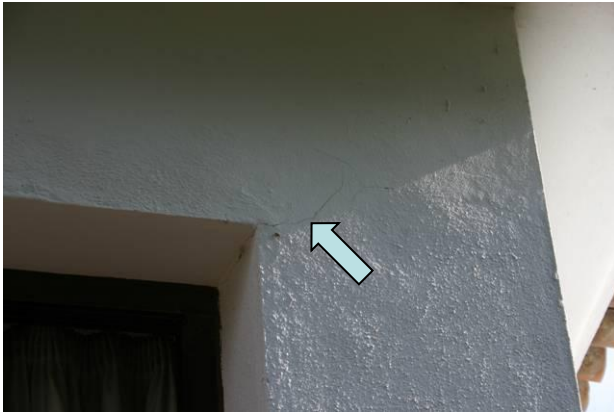
K

We do also have slight concerns that there is ongoing structural movement within the foundations and brickwork of a small addition to the main building and we believe further investigations are required at the Eastern elevation of the property. (small reception room). Please see notes below on settlement, and subsidence. In this respect an independent report may be required if this is necessary then this will require trial holes and testing to fully confirm the integrity of the substratum and the stability of this extensions foundations. At present the structural integrity of this small extension cannot be confirmed. **(K)**

I would like to bring to your attention though the room at the end of the lounge (East Elevation) this appears to be an addition. There are extensive movement cracks within this room. The fireplace which is a stable entity has movement cracks both sides where it meets the rear of the lounge wall. Also there are movement cracks where the rear of the lounge wall meets the ceiling. Externally and slightly more concerning is that movement cracks can be seen where they project through the ring beam at the South East Corner. **(K)** It can also be seen externally that the patio area adjacent to the patio doors from this room has subsided slightly and generated a movement crack between the terrace and the patio tiles.

The movement appears to be small but is still evident and we believe on going as the property appears to have been recently painted and patched, yet the movement cracks have opened again and removed areas of patched rendering. Further investigation ideally with intrusive investigation both above and below ground should be carried out in our opinion and possible compensation within the asking price must be calculated.

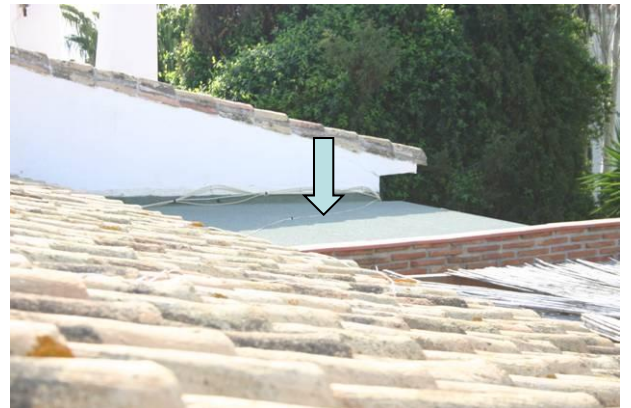
L

FLAT ROOF: The flat roof is forming the entrance porch into the main building and is unusually of a timber construction. However the structure appears to be in very good condition, with timbers remaining flat and the felted flat roof above appearing to be fairly new. No signs of leaks were apparent. **(L)**

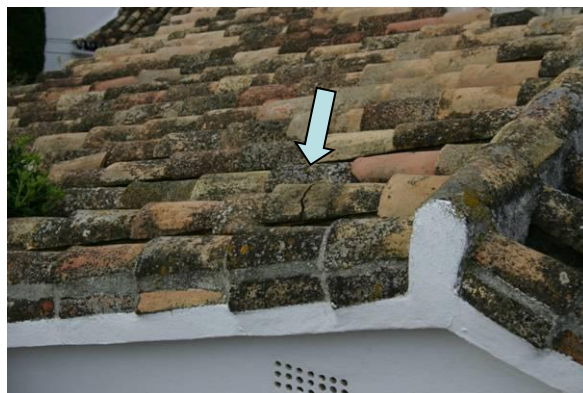
M

MAIN PITCHED AND ATTACHED ROOFS: All the roof areas are of a traditional Spanish format in construction. The roofs are tiled and the ridges are level and constant with no signs of movement or distortion. There are towards the front elevation of the building several damaged tiles these will need replacing and I would recommend the replacement of any cracked grouting at this time. (The roof as with many properties of this age and porous tile is suffering from moss growth and it would be advisable to have the tiles jet washed with a suitable cleaning agent. **(M)**
